111-50-10620-2006**DELIST****Water body name:****Survey date:** 1/23/2015**Water body number:** 111-50-10620-2006**Species & Lifestage:** COr, DVr**Watershed:** Mendenhall River-Frontal Gastineau Channel**MTR:** C040S066E **Quad:** Juneau B-2

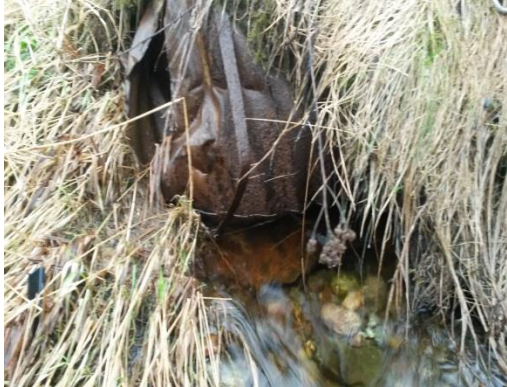
Figure 1.–Outlet of culvert under Old Dairy Road.

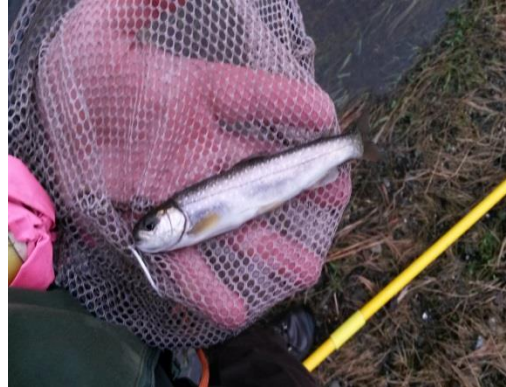
Figure 2.–Dolly Varden char captured at Old Dairy Road culvert.

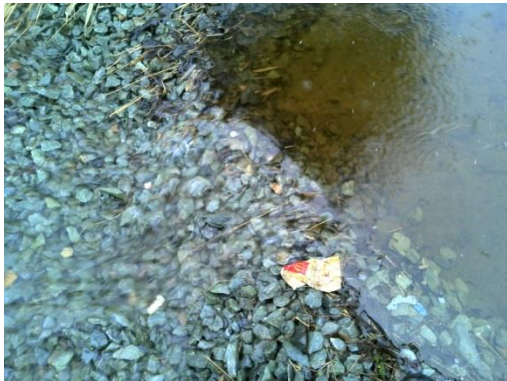
Figure 3.–Little rock fill that could be a fish block at low water.
